ENVIRONMENTAL AUDIT REPORT (2020-2021)

**INTERNAL QUALITY ASSURANCE CELL
UNIVERSITY OF CALICUT
October 2021**

ENVIRONMENTAL AUDIT REPORT OF THE CALICUT UNIVERSITY CAMPUS (2020 – 2021)

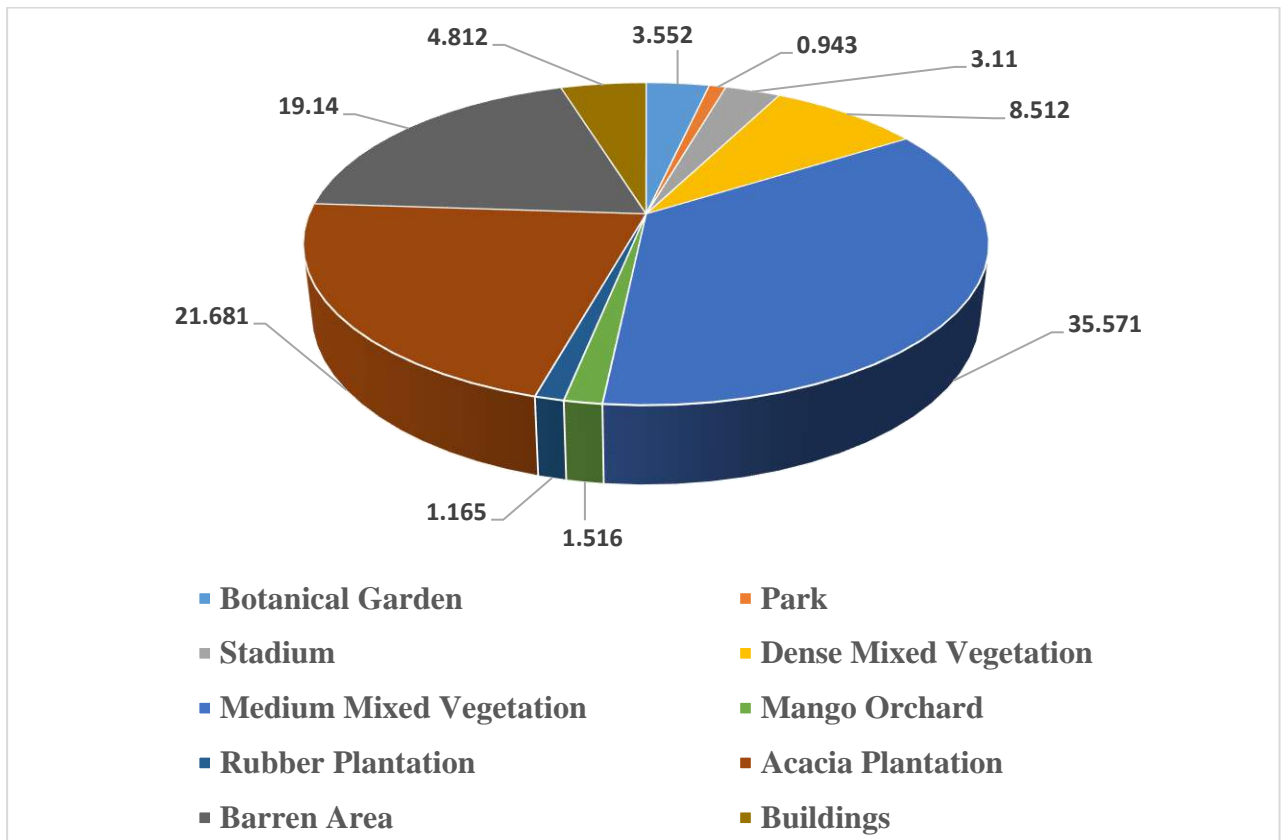
Fig. 3 (a). Vegetation and land resource utilization

not uniform and is remaining fragmented due to geological / geographical reasons and land management practices. Majority of the land is occupied by the medium-mixed type of vegetation (35.5%). Botanical Garden (3.55%) and University Park (0.94%) are protected areas within the campus, which provides conservation to a wide range of plants and associated organisms. Plantations of mango varieties, rubber and Acacia are also seen in the campus. Mango orchard (1.51%) is surrounded by dense and medium vegetation on one side and an extensive cover of Acacia (21.68%) on the other. Acacia forms a major environmental concern in the campus, owing to varied reasons and are to be replaced with native vegetation in the near future. Rubber plantation contributes to 1.16% of the total land area. Apart from this, completely barren area is estimated to be 385258.085 sq. m. (95.19 acres), representing 19.14% area of the campus.

The area occupied by the buildings have increased from 4.405% to 4.812% over a period of 5 years. The vegetation cover (both dense and medium mixed type) has decreased to an extent of 0.534% over these years. The barren area also showed an increase of 1.240%. The area under Acacia plantation has decreased to an extent of 0.982%. Considering these aspects, the following recommendations are made.

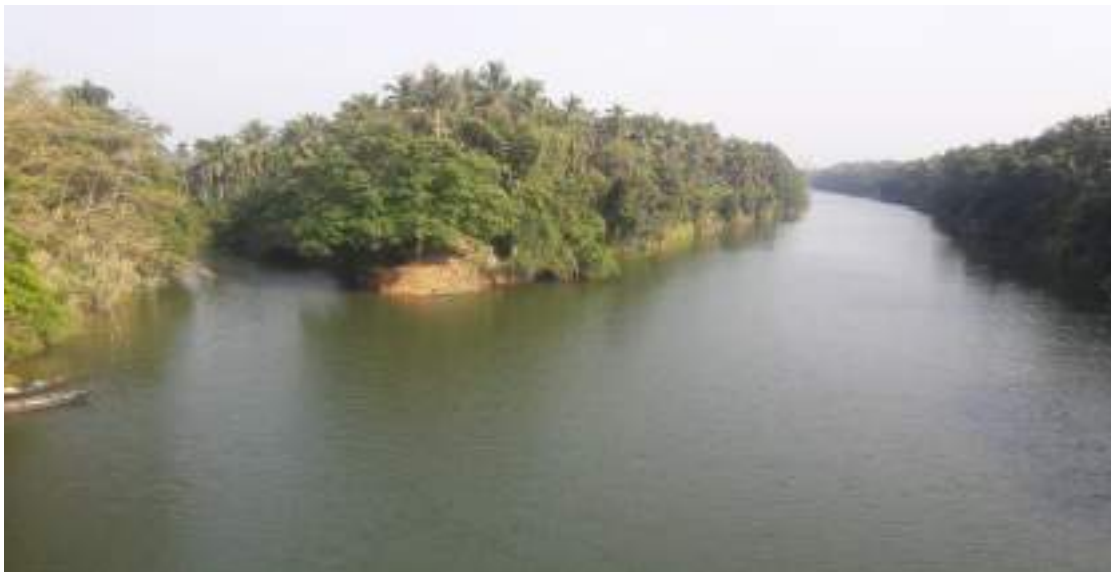
Plate 1. Kadalundi river at Parakkadavu region

The University of Calicut meets its requirement of water from Kadalundi river, ~10Km away from the campus. The water supply system comprises of an intake facility at Parakkadavu, booster facility at Chelari and a treatment facility at the Calicut University campus (Plates 1-3).

An evaluation of the quality of water (WQI) of the Kadalundi river at Parakkadavu region is noted to be 'good', except for microbiological parameters. Also, the level of contaminants is found to be increasing during summer months. This points to the need for effective water treatment options to be adopted by the University during peak summer months. Emphasis needs to be given for the microbial contaminants in water.

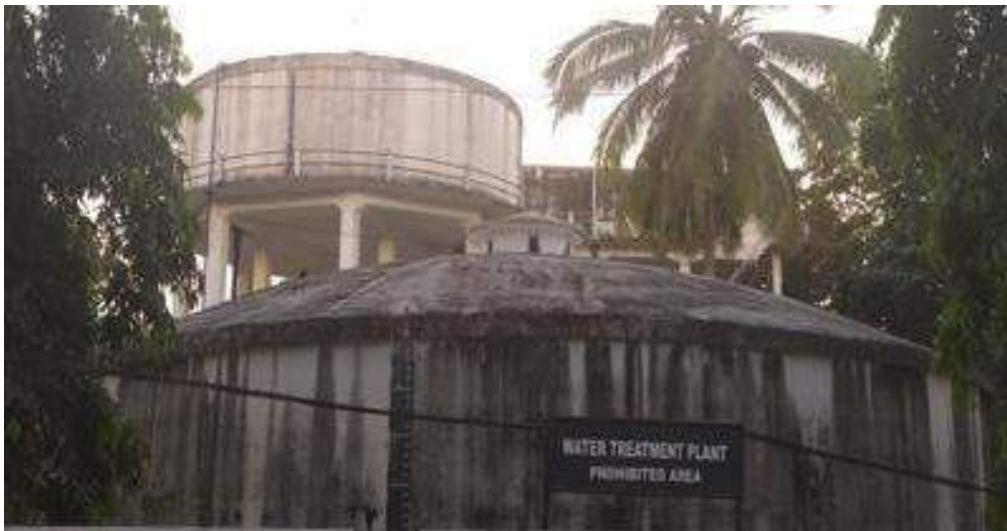
Plate 3. Water treatment facility at Calicut University Campus

The water treatment facility in the campus (as per Engineering Department) comprises of a Rapid Sand Filter Bed, which has a daily capacity of 10-16 Lakhs Liters. In accordance with the requirements of water within the campus, every day, 10-16 Lakhs Liters of water are pumped from Kadalundi River. The collected water is then mixed with alum and limestone at a concentration depending on the turbidity of the raw water. The water is then passed through the sand bed for filtration and normally 80,000 liters of water is filtered in an hour. In order to confirm proper disinfection, filtered water is mixed with moderate levels of bleaching powder, which maintains chlorine concentration within a permissible limit. Treated water is collected in a base tank (4.5

Lakhs Liter capacity) and pumped (using three 15 HP motors) to two overhead tanks (5 and 2.25 Lakhs Liters capacity each). Before distribution, the treated water is checked for various quality parameters.

The physico-chemical quality of treated water in the distribution system within the campus was noted to be Excellent in terms of WQI. However, the microbial quality of water in the distribution system has to be examined periodically for ensuring infallible treatment efficiency.

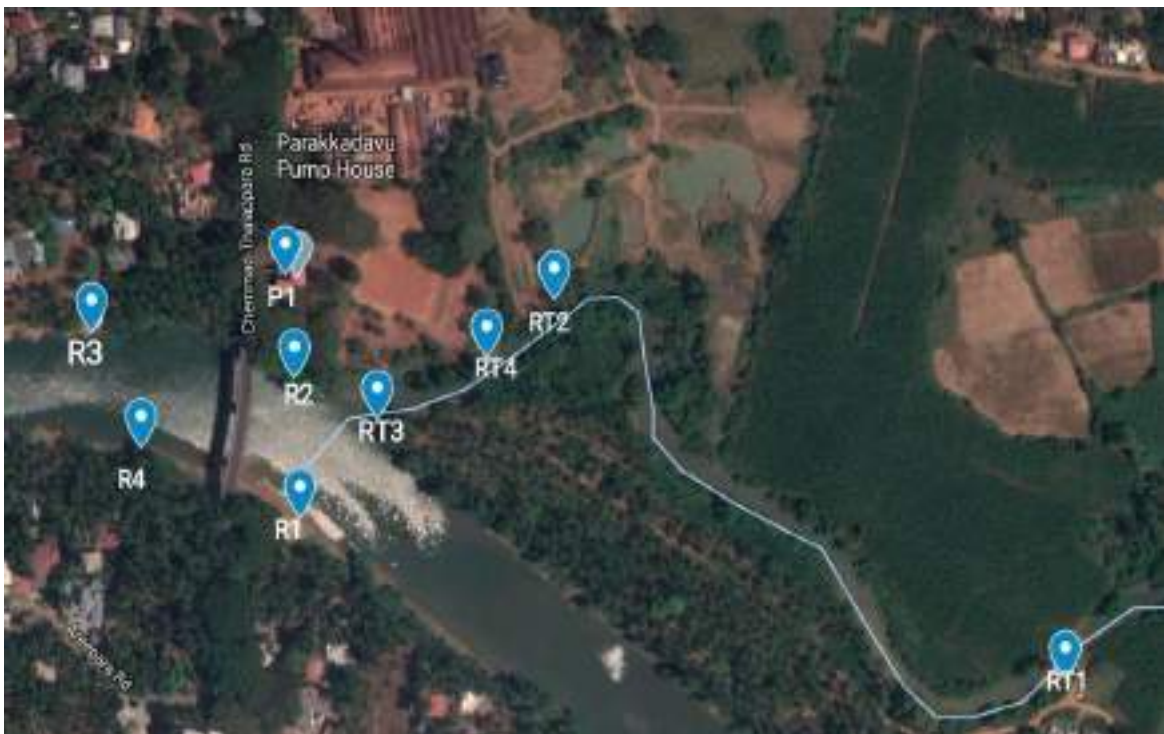
Plate 4.

Sampling sites of water quality assessment at Parakkadavu region of Kadalundi river

An assessment of the quality of water at the source (Parakkadavu) during early summer months (January and February) revealed that it is “Good” in terms of Water Quality Index. However, drastic deterioration in water quality was noticed with the progress of time from January to February. Microbial count represented by Total Coliforms and E. coli was higher in most of the sites studied. This is indicative of the poor quality of water during peak summer months (March – May). As Parakkadavu region experiences drastic decline in water table during peak summer months, the deterioration in water quality is certain. Also, the region is under terrific threat due to

The water table in Parakkadavu region of Kadalundi river is retreating at an alarming rate, leading to severe shortages and quality deterioration in the summer months. The University has to think of alternative sources of water for meeting such shortages in the near future. A detailed study is warranted in this regard.

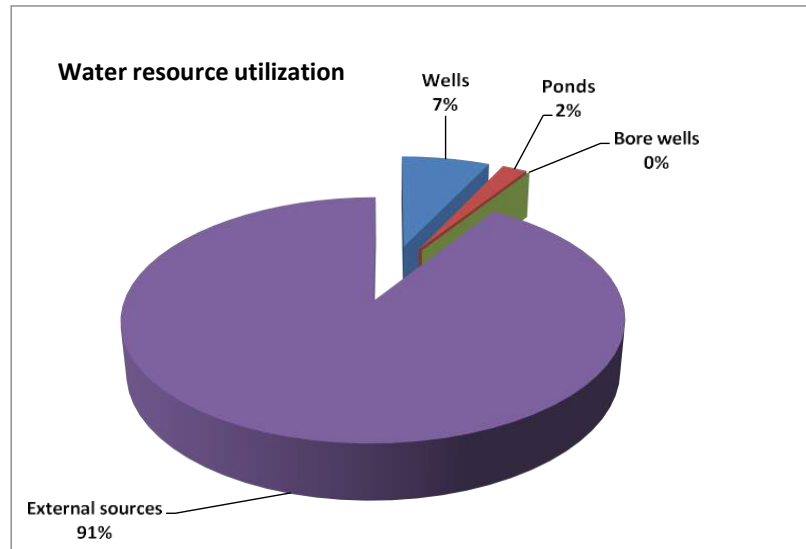
Figure 5. Water resources utilization in the campus

Water resource utilization in the campus is given in figure 5. The daily use of water by various sections of the campus community are depicted in Table 21 and their graphical representation in figure 6.
